ALABAMA HAZARDOUS WASTES MANAGEMENT AND MINIMIZATION ACT (AHWMMA)
Compliance Evaluation Inspection (CEI) Report

Sanmina Corporation (Sanmina)
13000 South Memorial Parkway
Huntsville, (Madison County), Alabama 35803

March 14, 2017

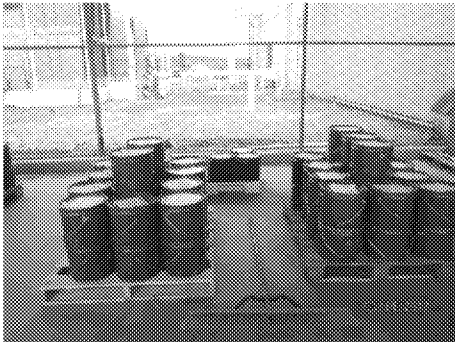
Photograph #1: 90-day Area: Lead Solder waste to be recycled

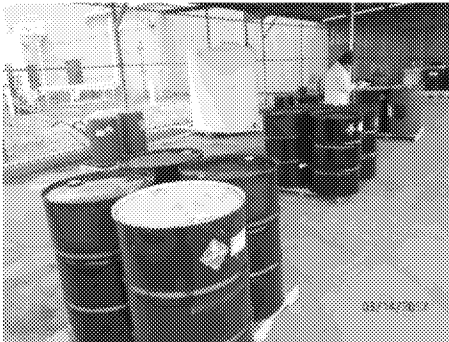
Photograph #2: 90-day Area: Eight drums of hazardous waste

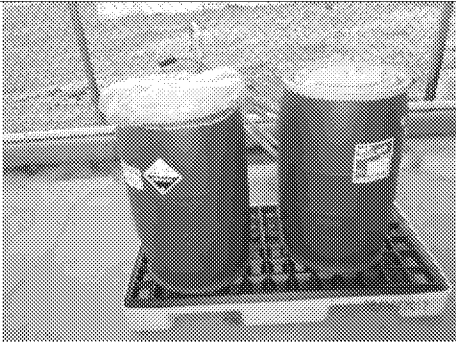
Photograph #3: 90-day Area: One-30 gallon drum of flux waste (left) and one 30-gallon drum of non-hazardous soapy water (right)

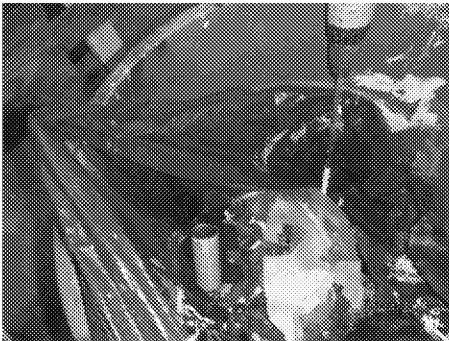
Next, Ms. Smolik escorted us to maintenance room. In this area, we observed a spent aerosol can that was disposed of in the trash not punctured (see Photograph #4). Staged along the wall, we observed five yellow fireproof metal cabinets. Each cabinet several gallon containers of water based and oil based paint and aerosol cans. Four aerosol cans staged in a metal cabinet were missing spray nozzles (see Photograph #5). Staged on a table in the maintenance room, we also observed a 5-gallon metal flammable flip top container. Inside the container was a solvent and paint brush. The container was not labeled to identify the contents inside (see Photograph #6 and #7).

Photograph #4: Maintenance Room: Aerosol can and paint can discarded in the garbage

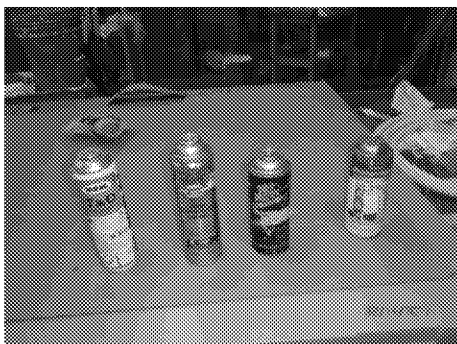
Photograph #5: Maintenance Room: Aerosol cans missing spray nozzles

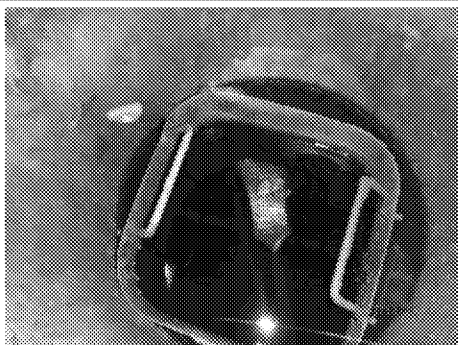
Photograph #7: Maintenance Room: Solvent and paint brush in the flammable flip top container

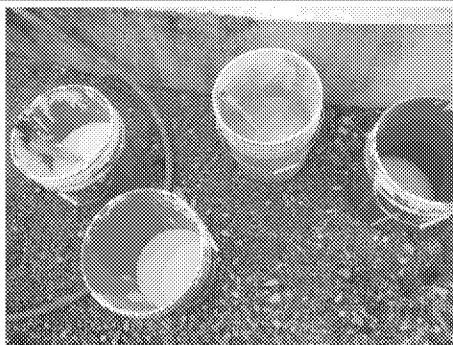
Photograph #8: Outside Tank Area: containers with paint waste

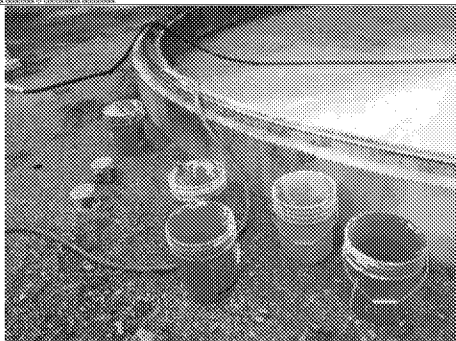
Photograph #9: Outside Tank Area: containers of paint waste

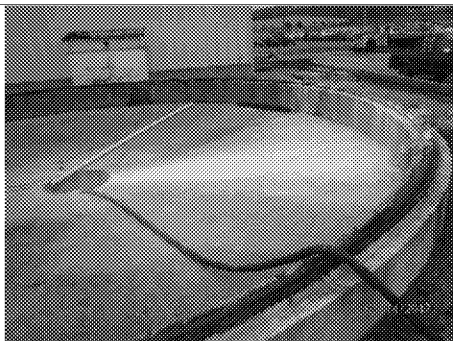
Photograph #10: Outside Tank Area: Paint Residue

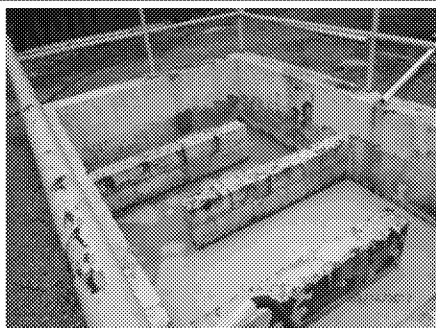
Next, Ms. Smolik escorted to an area that use to house a tank which is adjacent to the maintenance room. In this area, we observed five 5-gallon containers of paint waste and two plastic coffee containers that appear to be cleaned in this area and poured into sump pump. Inside the old tank area, we observed the concrete area covered in the white paint residue (see Photographs #8 through #10). The sump near the outside tank was also observed with residual paint and had a solvent smell (see Photograph #11 and #12). According to Ms. Smolik, the contents inside the sump are sent to city sewage.

Photograph #11: Sump near Outside Tank: with paint residual and solvent smell

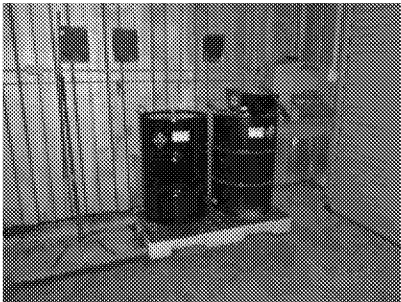
<p>Photograph #17: Satellite Accumulation Point Storage</p>

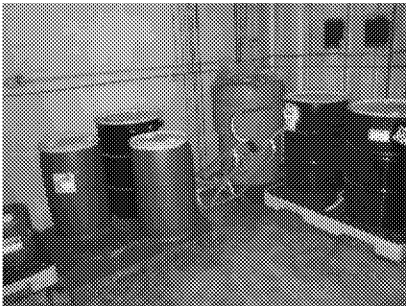
<p>Photograph #18: Satellite Accumulation Point Storage</p>

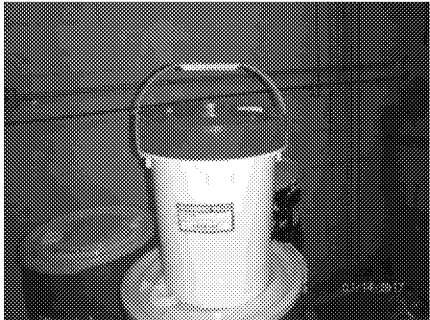
<p>Photograph #19: Satellite Accumulation Point Storage</p>
